<b>Title:</b>	<b>Green Power Switch Burned</b>			<b>ID:</b>
				0272
<b>Date in:</b>	<b>Response:</b>	<b>Model:</b>	<b>Author:</b>	
2006-12-01	2006-12-01	STX1000	CMa

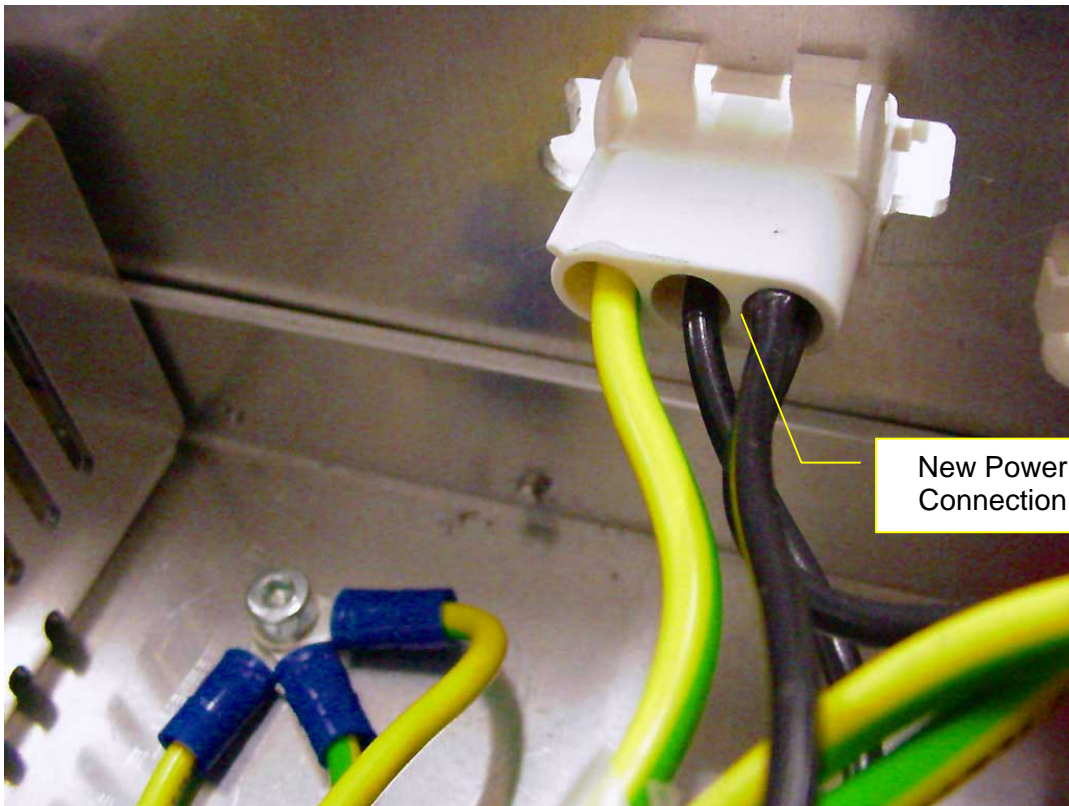
The green power switch melted twice on our STX1000. What can we do?

Add open power  
to Life Input
