| Title: | Service Note Connector Motor Cards | | | ID: |

Service Note

Connector Motor Card

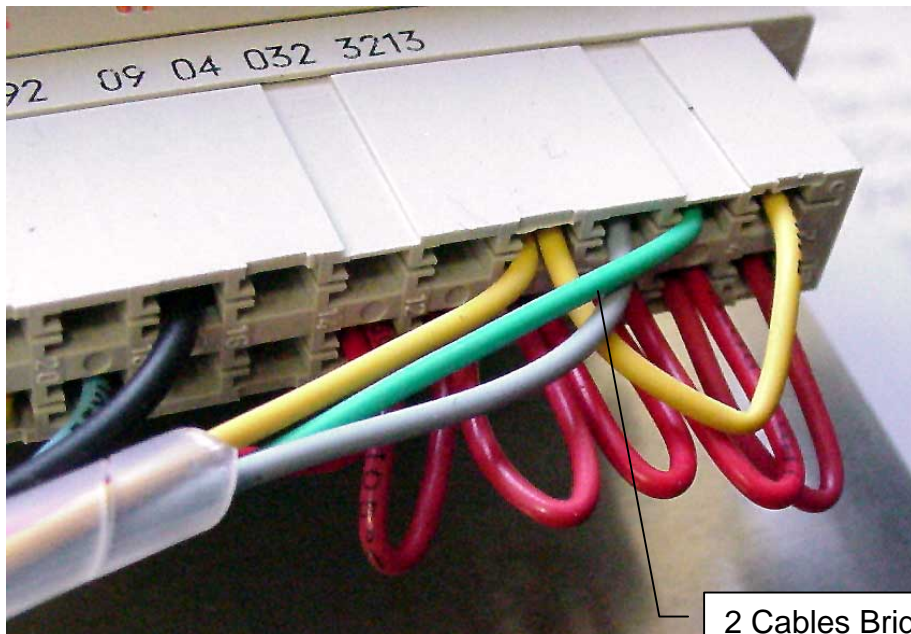
Crimp Contact were taken that are not suitable for two cables.

The metal core of one of the two cables may be broken.

Suitable pins were purchased. Contact pins on all modules on stock will be replaced.
