Title:	Glass Door Leaking	ID:	
		0287	
Date in:	Response:	Model:	Author:
2007-06-28	2007-06-28	STX40	CMa

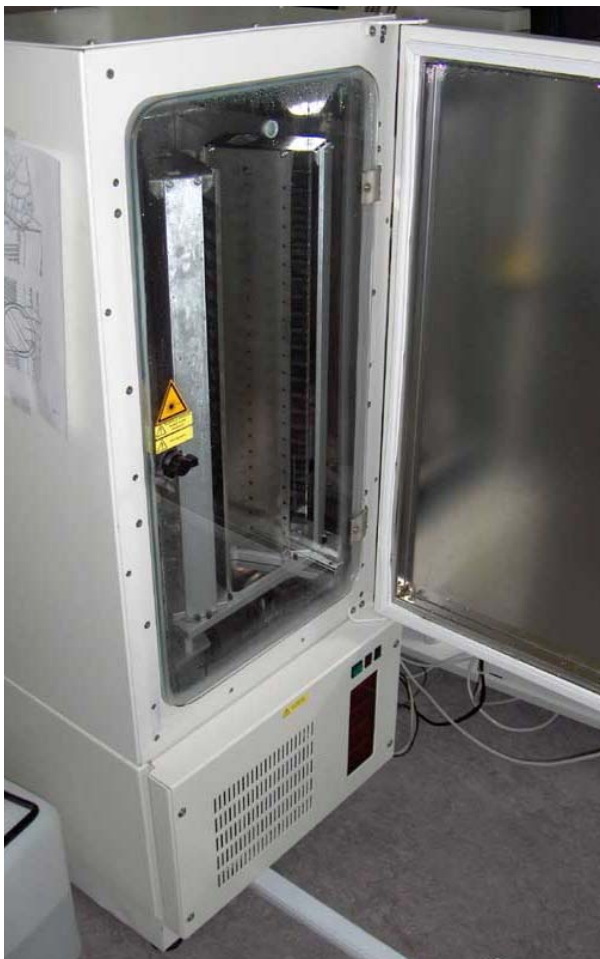
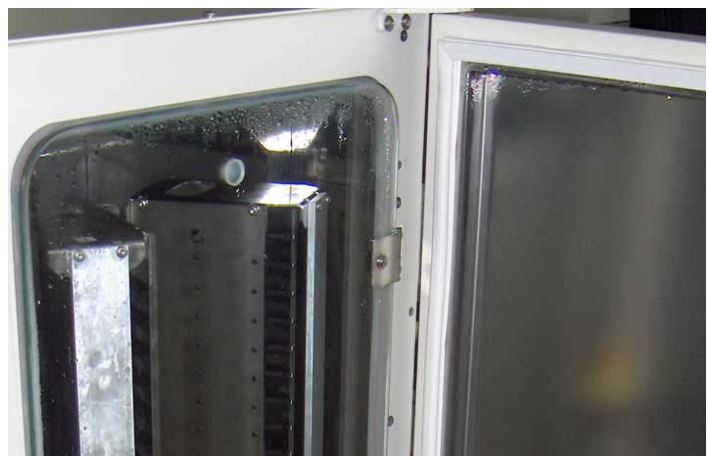
As promised here is the picture of our Storex. I do not know if you can see the water/condense on the glass door but there is still some left even though we switched it off? It is leaking from the right corner and here there is still some water left in the open door.

There are four correction steps that can be taken. Prior correction the seal may be checked using a stripe of paper.

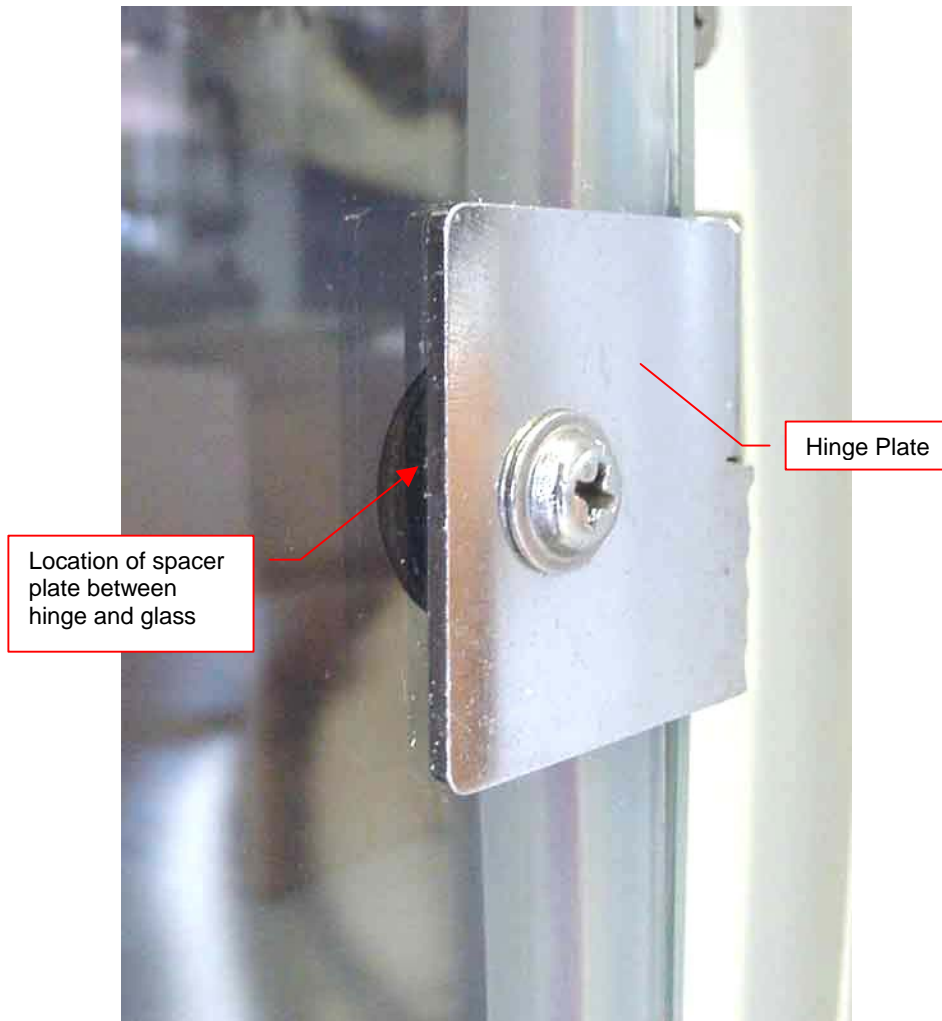
3. Increase Pressure on Door Seal

The pressure of the glass door may be increased by putting a spacer under the hinge plate. The spacer will be located between the hinge plate and the glass door moving the glass door surface closer to the opening of the chamber.
