<b>Title:</b>	<b>Green Power Switch Burned</b>			<b>ID:</b>
				0272
<b>Date in:</b>	<b>Response:</b>	<b>Model:</b>	<b>Author:</b>	
2006-12-01	2006-12-01	STX1000	CMa

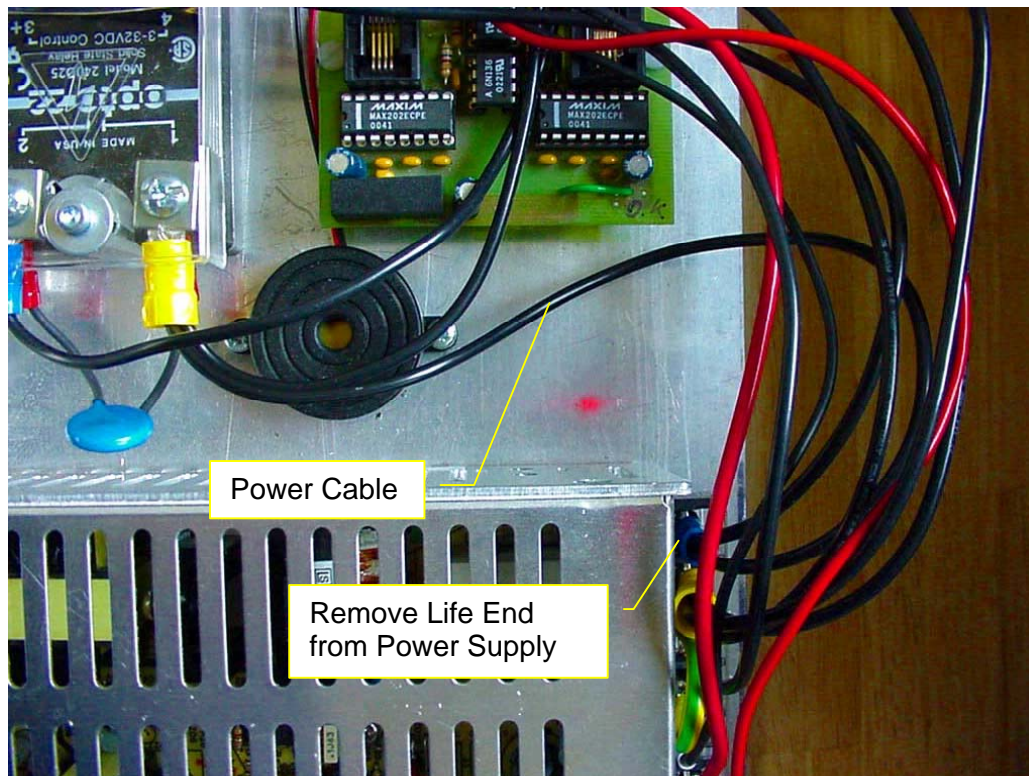
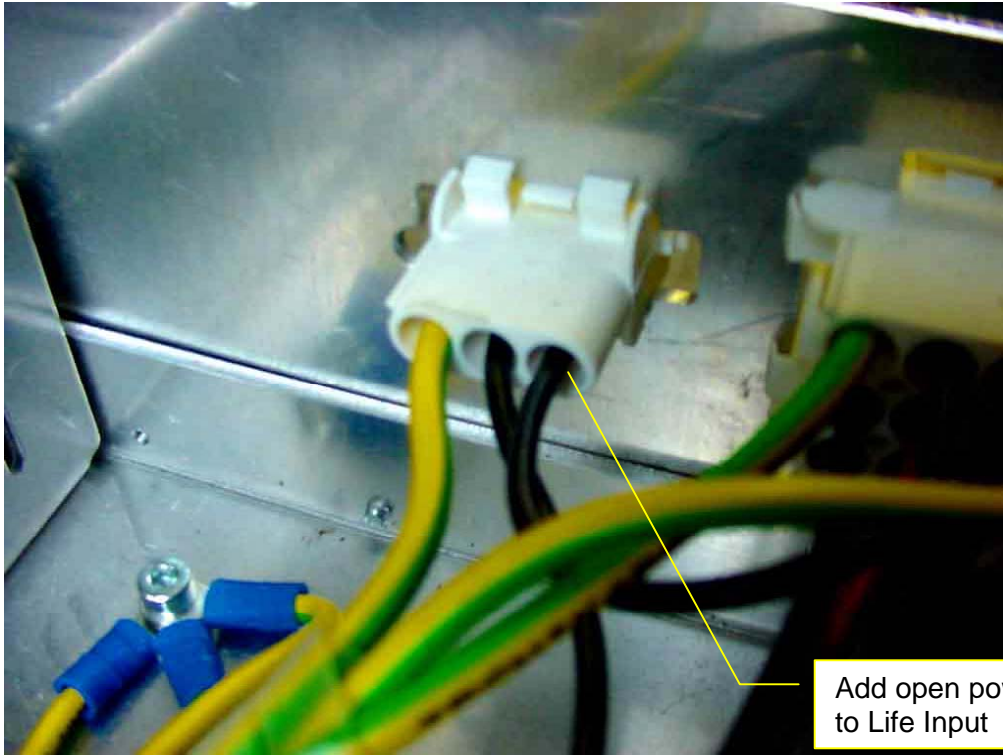
The green power switch melted twice on our STX1000. What can we do?

On the new wiring the low power is fed through the green front power switch only. You may change to the new wiring according below proc.

Add open power  
to Life Input
